Night Road Safety Inspection

Jakub Nováček¹ and Tomáš Kohout²

Abstract – Europe has committed to reduce the number of serious road traffic accidents. This requires building a safe infrastructure. Safety inspections are used to measure and increase the road safety. To fulfil the stated goals, the safety inspection must also be carried out at night, when specific road defects are encountered.

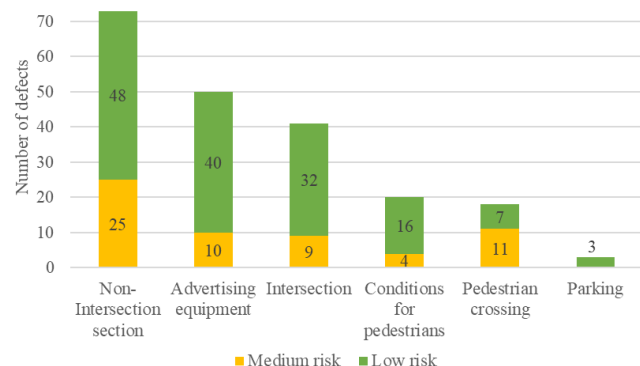
In this project, a total of four primary roads (I/19, I/20, I/26, I/27) with a total length of 213 km in the Pilsen Region were inspected [2][5][9]. The selected road sections had a different traffic characteristic which included not only the built-up areas but also the rural area. A total of 205 safety defects were identified on the road under the reduced visibility (Fig. 2). The low-risk defects were the most common (71.2%), followed by the medium-risk defects occurring in 28.8% of cases. The high-risk defects were not observed. The night-time defects were divided into 6 categories and a total of 14 types.

Fig. 2. Chart of recorded defects [9]

The most frequent group was the non-intersection category with 73 registered safety defects. The most common issues

were inadequate lighting of the traffic area or an insufficiently perceptible curve of the road.

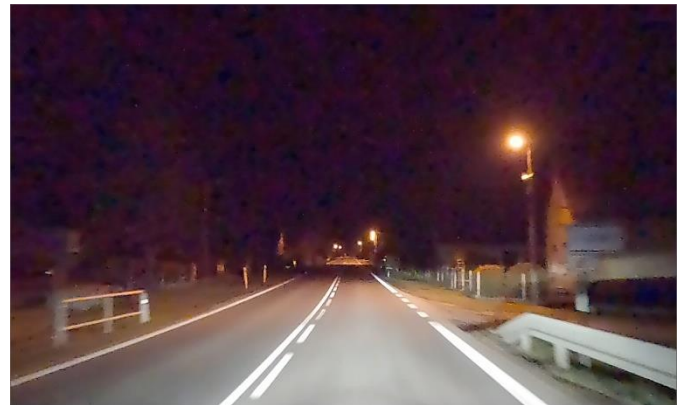
The first type of the mentioned defect was mostly found in the built-up areas, as these parts are usually illuminated (Fig 2 and 3). In this case, the areas are not illuminated by the public lighting and there is a so-called contrast shadow (unlit area in an otherwise illuminated section). This poses a major problem for the drivers whose eyes cannot adjust quickly enough to changes in light intensity. This is especially problematic in case, when a pedestrian who is moving in the unlit area may be overlooked and a serious accident can happen. The severity of these defects is increased by the fact that often no sidewalk is implemented at these locations.

Fig. 3. Example of contrast shadow in a built-up area [9]

In many cases, this defect can be effectively and inexpensively eliminated. In general, this problem is created by switching off a certain part of the public lighting (for example, every second lamp) to lower the costs for the operation of the lighting by the municipalities. Unfortunately, they often are not aware that it creates a potentially dangerous configuration for the road users.

If lamps are missing at a given location, then the solution is more difficult and expensive. It is necessary to carry out a detailed luminance analysis, according to which the following course of action can be decided. The most common practise is to replace the lighting bulbs or to increase the light intensity.

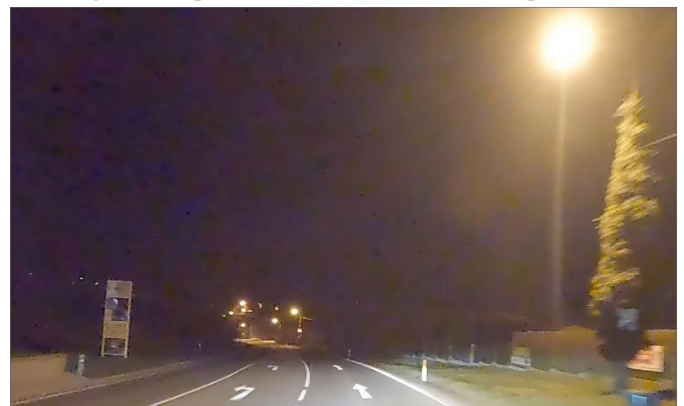
Fig. 4. Contrast shadow near the intersection [9]

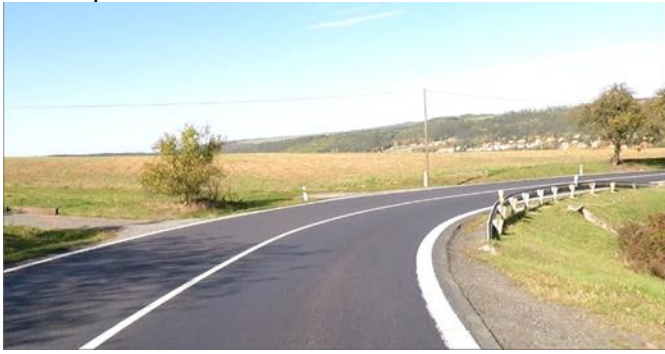
The second most frequent defects type was the hardly perceptible curve of the road (Fig 5 and 6). This type of defect was mostly identified in the rural area, where the traffic flow is outside the illuminated area, but also at higher speeds. In these places, traffic signs indicating the directional curve are most

often missing. Additionally, the directional posts on the sides of the road are missing as well and the horizontal markings are often in poor condition.

Fig. 5. View of a road curve during the day [9]

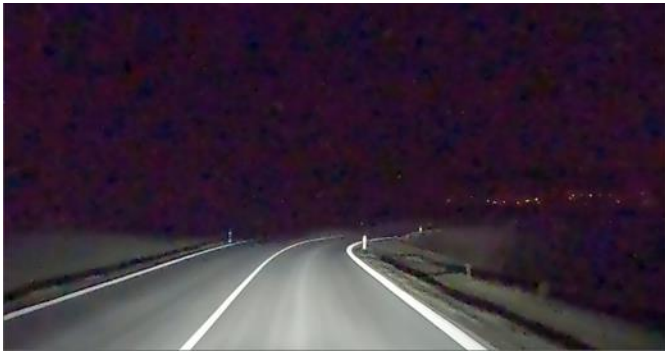
Fig. 6. View of a road curve at night [9]

The picture above shows a curve that is hard to see or predict at night. In this particular case, the risk of identified safety defect is further increased by several factors. The fact that the directional change is after a long straight stretch of the road and a power line pole in the near proximity of the road. Based on the statistics [6], if a curve is missed, the vehicle usually run off the road. A rigid obstacle in the form of a power line pole placed in the possible trajectory of the vehicle thus presents a fixed obstacle which may worsen the consequences of the accident. [8]

To ensure sufficient visibility of the road curve, it is possible to implement traffic signs that warn the driver. It is also possible to install additional directional signs on the outside of the curve to indicate the direction of the road to the driver. A properly marked road curve can be seen in the Fig. 7.

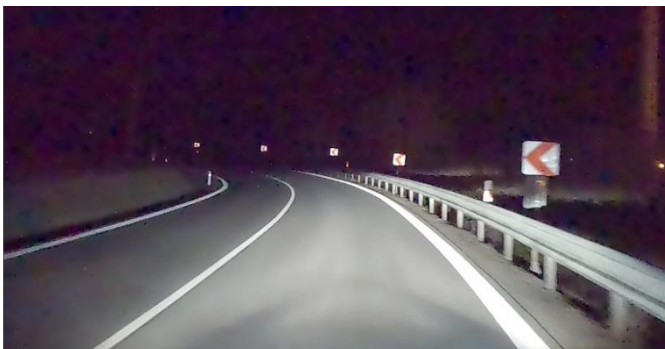
Fig. 7. An example of a well-marked curve with traffic signs [9]

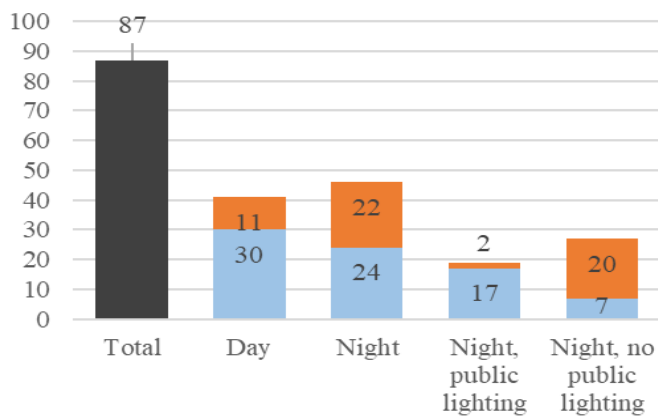
Fig. 9. Vehicle-pedestrian fatal accidents in the Czech Republic in 2019 (blue – Built-up area, orange – Rural area) [6]

The accident statistics show increased severity of the consequences in times of reduced visibility. As an example, the road traffic accidents involving the most vulnerable participants, pedestrians, can be shown. In 2019 alone, a total of 87 vehicle-pedestrian collisions with fatal injury were recorded. More than half of these cases (46 accidents) took place in the times of reduced visibility (at night). A total of 24 accidents were recorded in the built-up areas. Of these, 7 accidents occurred at a pedestrian crossing. The detailed distribution of these accidents is shown below (Fig. 9).
